Client: 22568A North Shore Terrace

**Comp #:** 100 Sidewalks, Patios, Curb - Repair

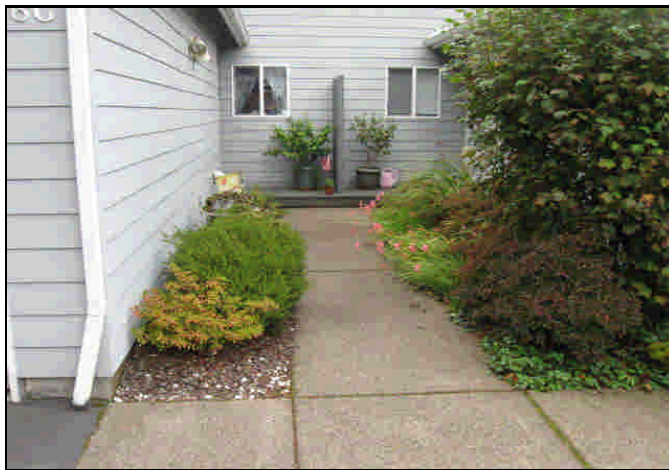
Evaluation: We noted generally stable condition with no significant damage/deterioration observed. Some minor local cracking and displacement. There was no record of large scale expenses (>\$2.500) noted within association expense history.

As routine maintenance, inspect regularly, pressure wash for appearance and repair promptly as needed to prevent water penetrating into the base and causing further damage. Repair any trip and fall hazards (1/2" or more displacement) immediately to ensure safety.

Larger repair/replacement expenses may emerge as the community ages, but are difficult to predict (timing, cost and scope) at this time. We suggest treating as a general maintenance expense - evaluating each year and allocating repair needs within the operating budget. If regular patterns of significant repair emerge in future, or need for a large renovation project becomes apparent, funding can be included within a future reserve study update. No reserve funding suggested at this time.

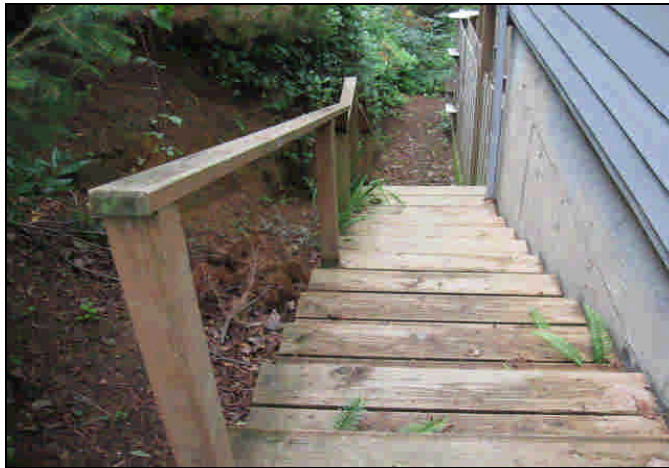
**Comp #:** 110 **Site Stairs - Repair/Replace**

Evaluation: Generally stable condition - no rot, damage or other advanced wear observed.

As routine maintenance, inspect regularly and perform any needed local repairs promptly as general maintenance expense to ensure that tread and rail connections are tight, secure and slip resistant. With ordinary care and maintenance, plan to replace at roughly the 25 year mark of life. Use quality treated, cedar, composite or similar with appropriate hardware for this coastal location (grade 316 stainless steel best).

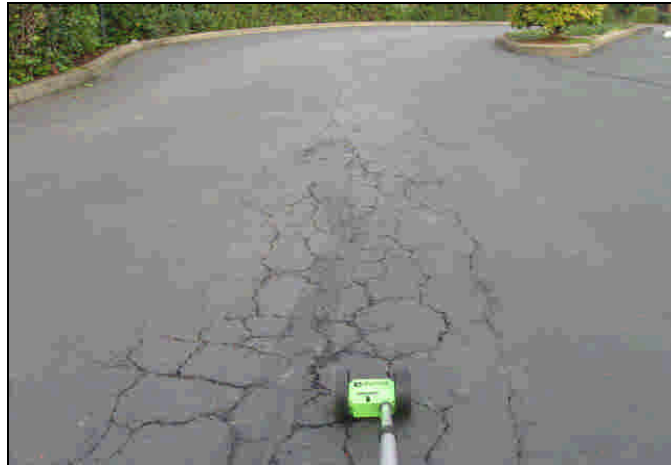
Evaluation: Overall fair condition. Some local alligator cracking, settling / waviness noted. Majority is stable.

We recommend having surface sealed and repaired as directed in component #121; regular cycles of seal coating are recommended for maximum design life. As routine maintenance, keep roadway clean, free of debris and well drained; fill/seal cracks to prevent water from penetrating into the sub-base and accelerating damage. Even with ordinary care and maintenance, plan for eventual large scale resurface (overlay) at roughly the time frame below. As timing draws nearer, consult with asphalt vendor/consultant for recommendations and complete scope.

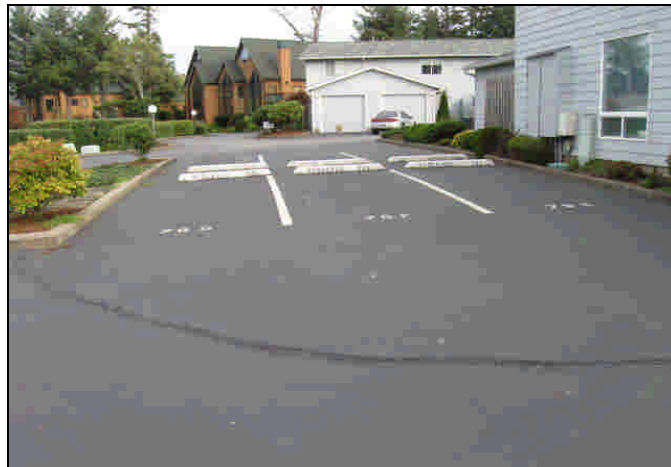
**Comp #:** 121 Asphalt - Seal/Repair/Stripe

Evaluation: Fair surface seal condition noted. Reportedly sealed in 2009 - areas of cracking were not sealed / repaired. We recommend seven year cycles to seal coat.

Regular cycles of seal coating (along with any needed repair) has proven to be the best program in our opinion for the long term care of lower traffic asphalt areas such as these. The State of Oregon, Department of Transportation recommends regular cycles of seal coating (they use the term bituminous surface treatment, BST) for the long-term care of asphalt paving with low traffic and low speed. The primary reason to seal coat asphalt pavement is to protect the pavement from the deteriorating effects of sun and water. When asphalt pavement is exposed, the asphalt oxidizes, or hardens which causes the pavement to become more brittle. As a result, the pavement will be more likely to crack, because it is unable to bend and flex when subjected to traffic and temperature changes. A seal coat combats this situation by providing a waterproof membrane, which not only slows down the oxidation process but also helps the pavement to shed water, preventing it from entering the base material. Seal coat also provides uniform appearance, concealing the inevitable patching and repairs which accumulate over time. Seal coat ultimately extends useful life of asphalt, postponing the asphalt resurfacing, which can be one of the larger cost items in the reserve study (see component #120 for asphalt resurfacing costs). Repair asphalt before seal coating. Surface preparation and dry weather, during and following application, is key to lasting performance. The ideal conditions are a warm, sunny day with low humidity; rain can cause major problems when seal coating and should never be done when showers are threatening. Apply two coats of flood application of quality asphalt emulsion. Incorporate any striping and curb repair into this project. Fill cracks and clean oil stains promptly in between cycles as routine maintenance.

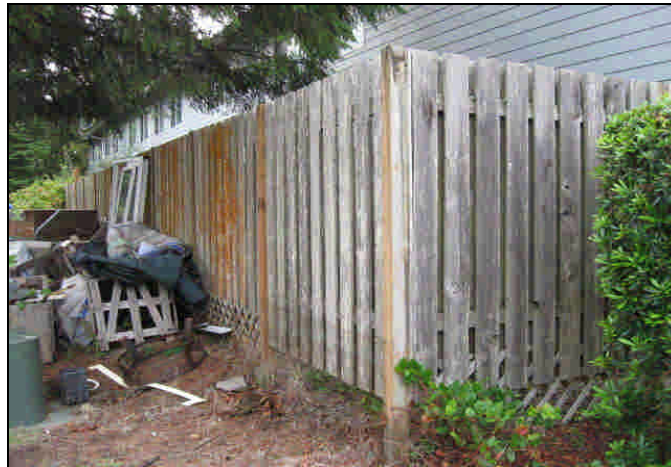
**Comp #:** 140 Bldg 66 Wood Fence - Replace

Evaluation: Poor condition with advanced wear throughout. Assumed to have been originally installed in 1992. Twenty year service life is upper end of range in our experience. No firm bids for replacement at this time - see below for typical cost range to remove and replace with quality treated / cedar fence.

As routine maintenance, inspect regularly for any damage, repair as needed and avoid contact with ground, surrounding vegetation and sprinkler patterns. Plan to replace soon; funding included here for similar wood replacement. Association might want to consider replacing with more sturdy, lesser maintenance products like composite, vinyl, fiber-cement, etc; typical costs at installation are about 30% higher, but requires less maintenance and will have longer life.

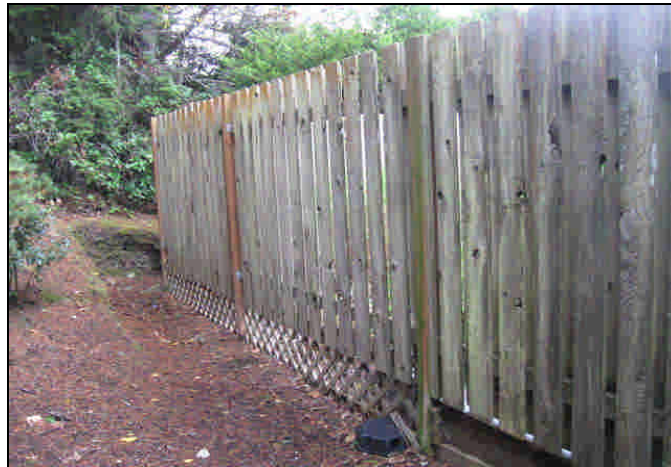
**Comp #:** 140 Bldg 76 Wood Fence - Replace

Evaluation: Poor condition with advanced wear throughout. Assumed to have been originally installed in 1993. Twenty year service life is upper end of range in our experience. No firm bids for replacement at this time - see below for typical cost range to remove and replace with quality treated / cedar fence.

As routine maintenance, inspect regularly for any damage, repair as needed and avoid contact with ground, surrounding vegetation and sprinkler patterns. Plan to replace soon; funding included here for similar wood replacement. Association might want to consider replacing with more sturdy, lesser maintenance products like composite, vinyl, fiber-cement, etc; typical costs at installation are about 30% higher, but requires less maintenance and will have longer life.

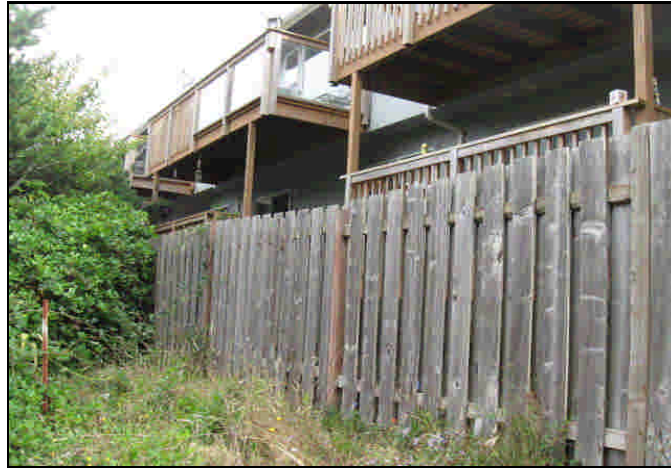
**Comp #:** 140 Bldg 85 Wood Fence - Replace

Evaluation: Stable condition - some local repair observed. Assumed new at time of building construction in 1997.

As routine maintenance, inspect regularly for any damage, repair as needed and avoid contact with ground, surrounding vegetation and sprinkler patterns. Plan to replace at roughly the time frame below; funding included here for similar wood replacement. At next replacement, association might want to consider replacing with more sturdy, lesser maintenance products like composite, vinyl, etc; typical costs at installation are about 30% higher, but requires less maintenance and will have longer life.

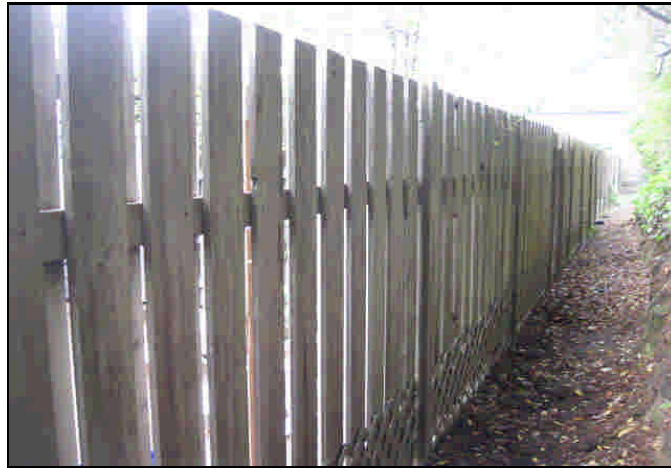
**Comp #:** 140 Bldg 86 Wood Fence - Replace

Evaluation: Poor condition with advanced wear throughout. Assumed to have been originally installed in 1992. Twenty year service life is upper end of range in our experience.

As routine maintenance, inspect regularly for any damage, repair as needed and avoid contact with ground, surrounding vegetation and sprinkler patterns. Funding included here for similar wood replacement. Association might want to consider replacing with more sturdy, lesser maintenance products like composite, vinyl, fiber-cement, etc; typical costs at installation are about 30% higher, but requires less maintenance and will have longer life.

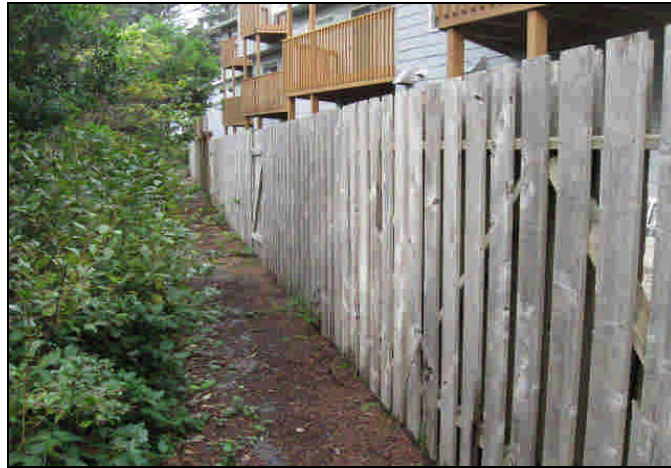
**Comp #:** 140 Bldg 96 A-D Wood Fence - Replace

Evaluation: Fair condition - stable, less wear than 66,76 and 86. Assumed to have been originally installed in 1994. Twenty year service life is upper end of range in our experience. Plan to replace within the next few years (2014 scheduled below).

As routine maintenance, inspect regularly for any damage, repair as needed and avoid contact with ground, surrounding vegetation and sprinkler patterns. Funding included here for similar wood replacement. Association might want to consider replacing with more sturdy, lesser maintenance products like composite, vinyl, fiber-cement, etc; typical costs at installation are about 30% higher, but requires less maintenance and will have longer life.

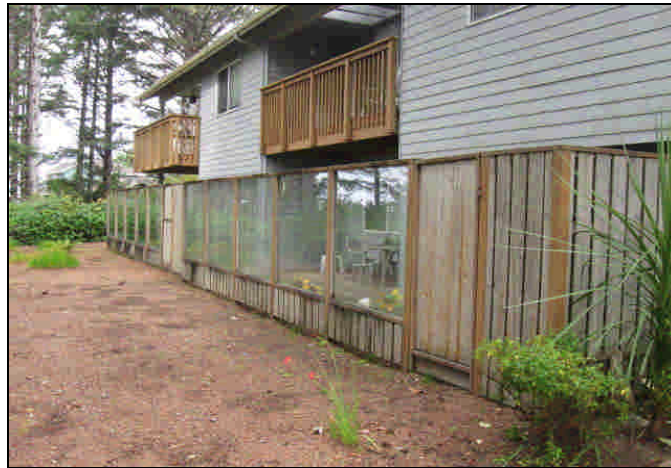
**Comp #:** 140 Bldg 96 E-H Wood Fence - Replace

Evaluation: Stable, but mildewed and worn in appearance. Assumed to have been originally installed in 1996. Twenty year service life is upper end of range in our experience. Plan to replace around the time frame indicated below.

As routine maintenance, inspect regularly for any damage, repair as needed and avoid contact with ground, surrounding vegetation and sprinkler patterns. Funding included here for similar wood replacement as other buildings.

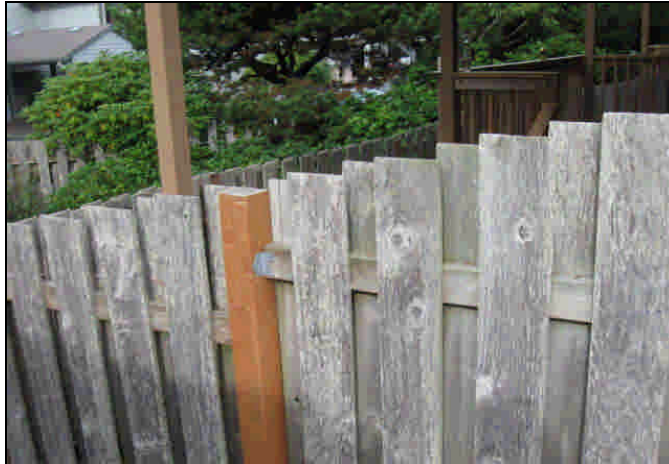
**Comp #:** 141 Wood Fence - Clean/Stain

Evaluation: Existing wood fence has not been stained. We assume this policy will continue, with fence left to naturally weather / gray. Therefore, no basis for reserve funding. As routine maintenance, fence should be cleaned, any contact with ground or vegetation removed and any local repair performed as general maintenance expense. For information purposes, typical clean and stain with quality product is in the \$3.00 to \$4.00 per linear foot range.

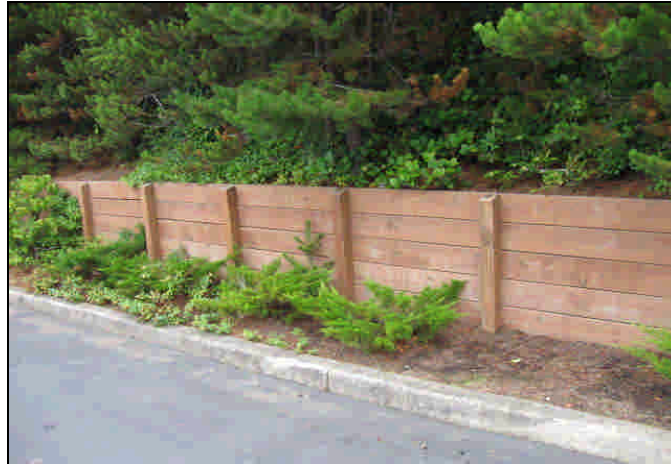
**Comp #:** 157 Retention Walls - Repair/Replace

Evaluation: Fair, stable condition noted with no obvious wood deterioration or other problems observed. Treated wood material. Assumed to have been properly designed and installed with adequate base and surrounding drainage. Inspect regularly, repair as needed from operating budget. If shifting, cracking, etc. are observed, consult with appropriate professional for repair scope. At this time, no predictable expectation of large scale repairs or replacement; no reserve funding recommended.

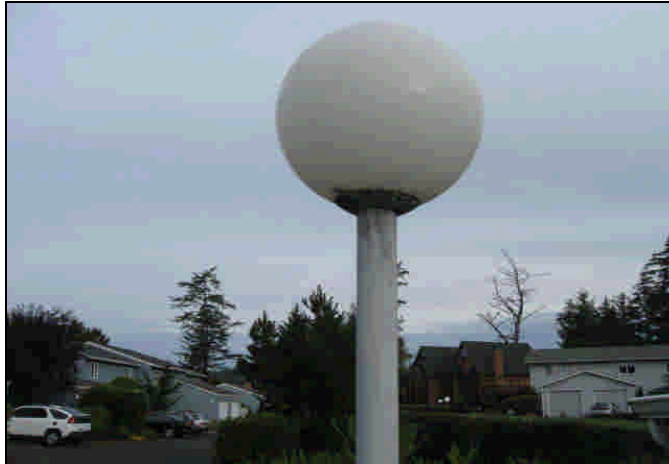
**Comp #:** 160 Pole Lights - Replace

Evaluation: Fair to poor condition noted. Generally stable, but globes show local damage, fading and wear. Observed during daylight hours; assumed to be in functional operating condition.

As routine maintenance, inspect, repair/change bulbs as needed. Best to plan for large scale replacement at roughly the time frame below for cost efficiency and consistent quality/appearance throughout association.

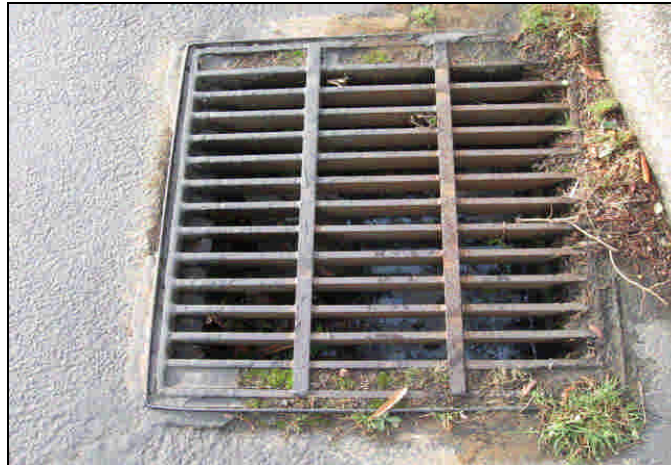
Evaluation: Our reserve study includes only a visual review, and majority of the drainage system is out of view. The (6) catch basins viewed all had standing water and debris.

As routine maintenance, inspect regularly, keep drains and grates free of debris and free flowing to ensure water drains as designed. Pipes can be 'scoped' to allow visual review of the interior of pipes. Repair as needed, including pumping out sediment, if needed, utilizing mobile evacuator service. Fund from operating and maintenance budget. No predictable expectation of large-scale repairs/replacement at this time. Therefore, no basis for reserve funding at this time.

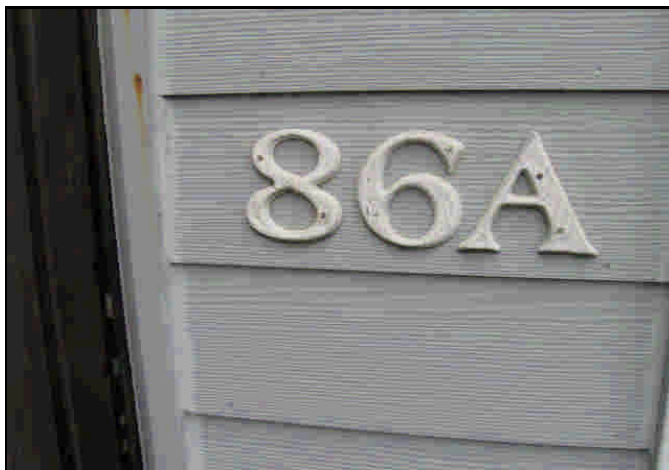
Evaluation: There is no entry monument sign. Lettering / numbering is in legible condition with no significant damage/deterioration noted. As routine maintenance, inspect regularly, clean/touch up for appearance and repair from operating budget. Too small of a component to merit reserve funding.

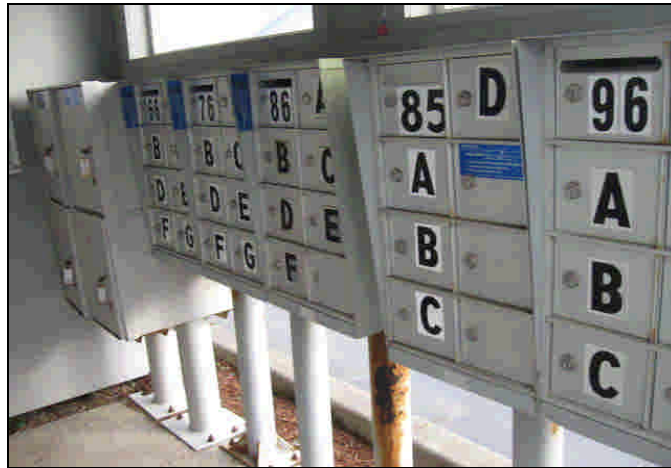
**Comp #:** 205 Mailboxes - Replace

Evaluation: (4) 8 unit cluster boxes (1) 12 unit (2) vinyl parcel lockers. Fair to poor condition of metal cluster stands/boxes with rust throughout base and hardware. No functional problems reported. Inspect regularly, clean by wiping down for appearance, change lock cylinders, lubricate hinges and paint bases with rust inhibitor, repair as needed from operating budget. Best to plan for total replacement at roughly the time frame below due to constant exposure, usage and wear over time. Note: USPS has a limited budget for replacement and should not be relied upon for purposes of long term planning.

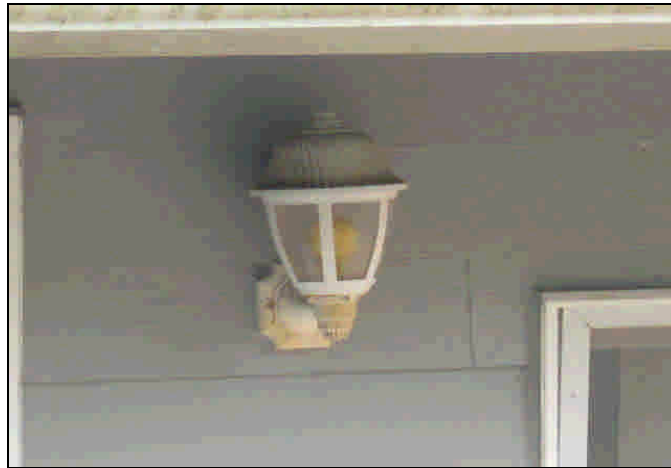
**Comp #:** 324 Exterior Lights - Replace

Evaluation: Varying condition of lights; no damage or unusual wear noted. Observed during daylight hours and assumed to be in functional operating condition. As routine maintenance, inspect, repair/change bulbs as needed. Because the ages vary throughout and each buildings exterior lighting can generally be replaced for less than \$1,500 we suggest it is not appropriate for reserve funding. We suggest individual fixtures be replaced as needed, or included in the operating budget, best timed to coincide with exterior paint cycles. No reserve funding suggested at this time.

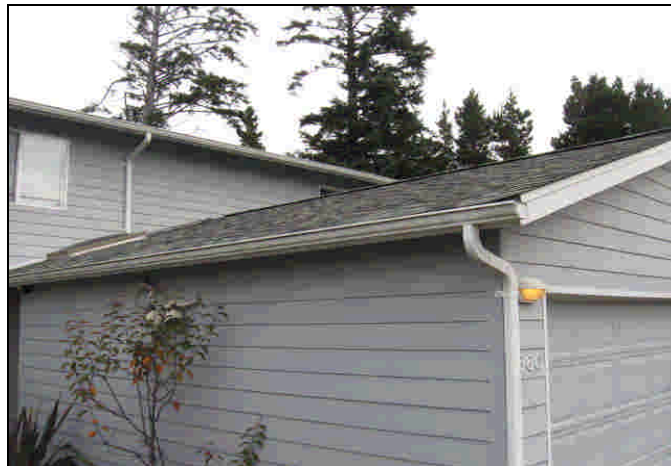
**Comp #:** 500 Bldg 66 Roof - Replace

Evaluation: Roofing is three tab shingles, reportedly replaced last in 2006 with Malarkey Rubberized spec. Ventilation (the lack of which can greatly reduce useful life) was observed at both eave and ridge. Eave venting consisted of circular holes in blocking between rafters. Ridge venting appeared to be provided by continuous ridge vents. Visible portions of roof flashing were observed at the rake, headwall, and sidewall conditions. Kick out flashings were observed. Gutters blocked the view of eaves, so eave flashing was not confirmed. Some local debris and moss observed.

This type of roofing typically has a 15 to 18 year service life assuming it was properly installed and is properly maintained. As routine maintenance, many manufacturers recommend inspections at least twice annually (once in the fall, before the rainy season, and again in the spring) and after large storm events. Promptly replace any damaged/missing sections or any other repair needed to ensure waterproof integrity of roof. Keep roof surface, gutters and downspouts clear and free of moss or debris. Moss growth can decrease the life of the roofing shingles and should be removed sooner than later. Liquid applied fungicide (moss killer) is recommended instead of power washing the living moss off the shingles. Moss roots grow into the shingles. Killing the moss in-place, with a fungicide, allows the roots to gradually release from the shingles. After roots have died and released, then the moss can be removed (with broom or low pressure water) taking care to not damage the shingles. Do not use high-pressure water to remove moss as the high-pressure can loosen granular surface of shingles, erode the shingle surface, reducing the remaining useful life.

Plan for replacement at roughly the time frame indicated below. Costs below include replacing with a similar shingle to what is currently in place. We suggest that the best value (life cycle cost) might be to spend about \$2 - \$3/square foot more and install a 50-year shingle.

At time of re-roof we recommend that you hire a professional roof consultant such as Architect, Engineer, or building envelope consultant; to evaluate, design, specify, help bid the project, select best bidder, and observe construction to ensure proper installation. We recommend all Associations seek advice from a qualified consultant whenever they are considering having work performed on any building envelope components (roof, walls, windows, decks, exterior painting and caulking/sealant).

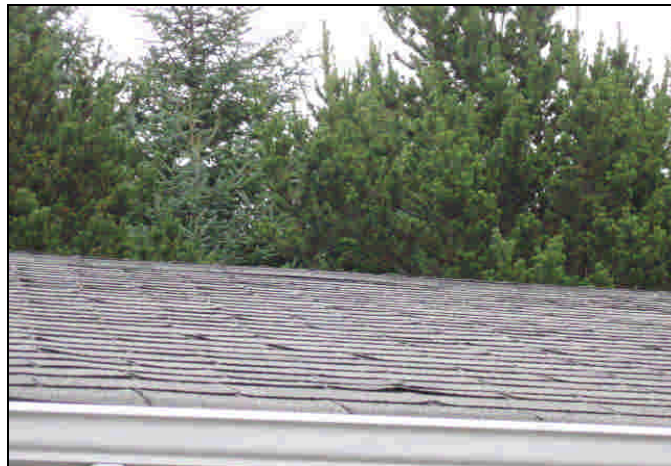
**Comp #:** 500 Bldg 76 Roof - Replace

Evaluation: Roofing is three tab shingles, reportedly replaced last in 2005 with Malarkey Rubberized spec. Some local minor edge curling, but no missing shingles or obvious damage. Ventilation (the lack of which can greatly reduce useful life) was observed at both eave and ridge. Eave venting consisted of circular holes in blocking between rafters. Ridge venting appeared to be provided by continuous ridge vents. Visible portions of roof flashing were observed at the rake, headwall, and sidewall conditions. Kick out flashings were observed. Gutters blocked the view of eaves, so eave flashing was not confirmed. Some local debris and moss observed.

This type of roofing typically has a 15 to 18 year service life assuming it was properly installed and is properly maintained. As routine maintenance, many manufacturers recommend inspections at least twice annually (once in the fall, before the rainy season, and again in the spring) and after large storm events. Promptly replace any damaged/missing sections or any other repair needed to ensure waterproof integrity of roof. Keep roof surface, gutters and downspouts clear and free of moss or debris. Moss growth can decrease the life of the roofing shingles and should be removed sooner than later. Liquid applied fungicide (moss killer) is recommended instead of power washing the living moss off the shingles. Moss roots grow into the shingles. Killing the moss in-place, with a fungicide, allows the roots to gradually release from the shingles. After roots have died and released, then the moss can be removed (with broom or low pressure water) taking care to not damage the shingles. Do not use high-pressure water to remove moss as the high-pressure can loosen granular surface of shingles, erode the shingle surface, reducing the remaining useful life.

Plan for replacement at roughly the time frame indicated below. Costs below include replacing with a similar shingle to what is currently in place. We suggest that the best value (life cycle cost) might be to spend about \$2 - \$3/square foot more and install a 50-year shingle.

At time of re-roof we recommend that you hire a professional roof consultant such as Architect, Engineer, or building envelope consultant; to evaluate, design, specify, help bid the project, select best bidder, and observe construction to ensure proper installation. We recommend all Associations seek advice from a qualified consultant whenever they are considering having work performed on any building envelope components (roof, walls, windows, decks, exterior painting and caulking/sealant).

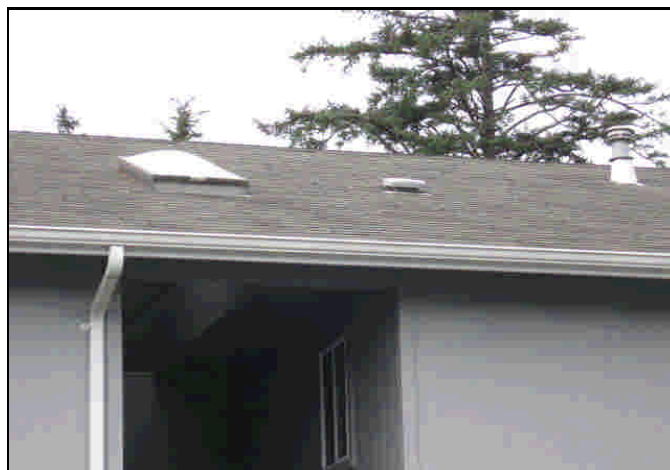
**Comp #:** 500 Bldg 85 Roof - Replace

Evaluation: Roofing is three tab shingles; original, installed in 1997. No reported leaks, no missing shingles or obvious damage. Ventilation (the lack of which can greatly reduce useful life) was observed at the eave; ridge was difficult to observe due to height. Eave venting consisted of circular holes in blocking between rafters. Visible portions of roof flashing were observed at the rake, headwall, and sidewall conditions. Gutters blocked the view of eaves, so eave flashing was not confirmed.

This type of roofing typically has a 15 to 18 year service life assuming it was properly installed and is properly maintained. As routine maintenance, many manufacturers recommend inspections at least twice annually (once in the fall, before the rainy season, and again in the spring) and after large storm events. Promptly replace any damaged/missing sections or any other repair needed to ensure waterproof integrity of roof. Keep roof surface, gutters and downspouts clear and free of moss or debris. Moss growth can decrease the life of the roofing shingles and should be removed sooner than later. Liquid applied fungicide (moss killer) is recommended instead of power washing the living moss off the shingles. Moss roots grow into the shingles. Killing the moss in-place, with a fungicide, allows the roots to gradually release from the shingles. After roots have died and released, then the moss can be removed (with broom or low pressure water) taking care to not damage the shingles. Do not use high-pressure water to remove moss as the high-pressure can loosen granular surface of shingles, erode the shingle surface, reducing the remaining useful life.

Plan for replacement at roughly the time frame indicated below. Costs below include replacing with a similar shingle to what is currently in place. We suggest that the best value (life cycle cost) might be to spend about \$2 - \$3/square foot more and install a 50-year shingle.

At time of re-roof we recommend that you hire a professional roof consultant such as Architect, Engineer, or building envelope consultant; to evaluate, design, specify, help bid the project, select best bidder, and observe construction to ensure proper installation. We recommend all Associations seek advice from a qualified consultant whenever they are considering having work performed on any building envelope components (roof, walls, windows, decks, exterior painting and caulking/sealant).

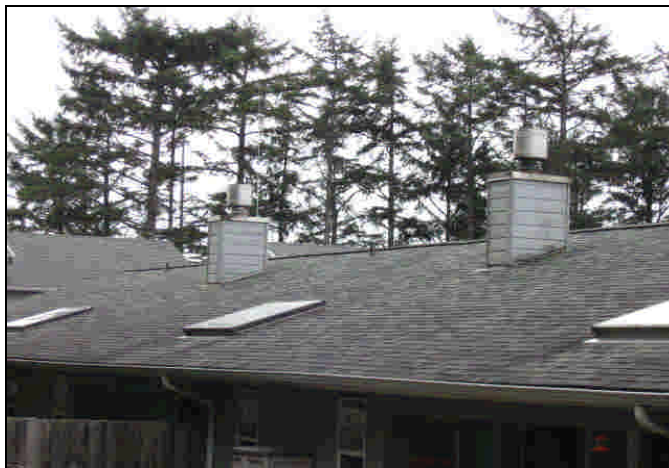
**Comp #:** 500 Bldg 86 Roof - Replace

Evaluation: Roofing is three tab shingles; reportedly replaced in 2005 with Malarkey Rubberized spec. No reported leaks, no missing shingles or obvious damage. Ventilation (the lack of which can greatly reduce useful life) was observed at the eave and ridge. Visible portions of roof flashing were observed at the rake, headwall, and sidewall conditions. Gutters blocked the view of eaves, so eave flashing was not confirmed.

This type of roofing typically has a 15 to 18 year service life assuming it was properly installed and is properly maintained. As routine maintenance, many manufacturers recommend inspections at least twice annually (once in the fall, before the rainy season, and again in the spring) and after large storm events. Promptly replace any damaged/missing sections or any other repair needed to ensure waterproof integrity of roof. Keep roof surface, gutters and downspouts clear and free of moss or debris. Moss growth can decrease the life of the roofing shingles and should be removed sooner than later. Liquid applied fungicide (moss killer) is recommended instead of power washing the living moss off the shingles. Moss roots grow into the shingles. Killing the moss in-place, with a fungicide, allows the roots to gradually release from the shingles. After roots have died and released, then the moss can be removed (with broom or low pressure water) taking care to not damage the shingles. Do not use high-pressure water to remove moss as the high-pressure can loosen granular surface of shingles, erode the shingle surface, reducing the remaining useful life.

Plan for replacement at roughly the time frame indicated below. Costs below include replacing with a similar shingle to what is currently in place. We suggest that the best value (life cycle cost) might be to spend about \$2 - \$3/square foot more and install a 50-year shingle.

At time of re-roof we recommend that you hire a professional roof consultant such as Architect, Engineer, or building envelope consultant; to evaluate, design, specify, help bid the project, select best bidder, and observe construction to ensure proper installation. We recommend all Associations seek advice from a qualified consultant whenever they are considering having work performed on any building envelope components (roof, walls, windows, decks, exterior painting and caulking/sealant).

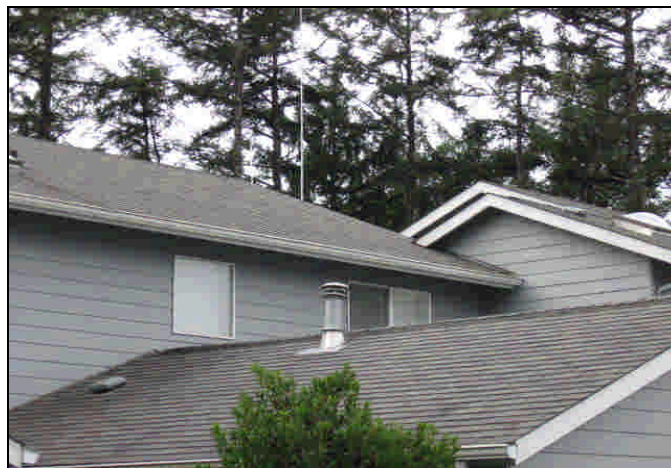
Comp #: 500 Bldg 96 A-D Roof - Replace

Evaluation: Roofing is three tab shingles; original, installed in 1994. No reported leaks, no missing shingles or obvious damage. Ventilation (the lack of which can greatly reduce useful life) was observed at the eave; ridge was difficult to observe due to height. Eave venting consisted of circular holes in blocking between rafters. Visible portions of roof flashing were observed at the rake, headwall, and sidewall conditions. Gutters blocked the view of eaves, so eave flashing was not confirmed.

This type of roofing typically has a 15 to 18 year service life assuming it was properly installed and is properly maintained. No current leaks reported - due to cash flow needs, replacement deferred below until 2013. As routine maintenance, many manufacturers recommend inspections at least twice annually (once in the fall, before the rainy season, and again in the spring) and after large storm events. Promptly replace any damaged/missing sections or any other repair needed to ensure waterproof integrity of roof. Keep roof surface, gutters and downspouts clear and free of moss or debris. Moss growth can decrease the life of the roofing shingles and should be removed sooner than later. Liquid applied fungicide (moss killer) is recommended instead of power washing the living moss off the shingles. Moss roots grow into the shingles. Killing the moss in-place, with a fungicide, allows the roots to gradually release from the shingles. After roots have died and released, then the moss can be removed (with broom or low pressure water) taking care to not damage the shingles. Do not use high-pressure water to remove moss as the high-pressure can loosen granular surface of shingles, erode the shingle surface, reducing the remaining useful life.

Plan for replacement at roughly the time frame indicated below. Costs below include replacing with a similar shingle to what is currently in place. We suggest that the best value (life cycle cost) might be to spend about \$2 - \$3/square foot more and install a 50-year shingle.

At time of re-roof we recommend that you hire a professional roof consultant such as Architect, Engineer, or building envelope consultant; to evaluate, design, specify, help bid the project, select best bidder, and observe construction to ensure proper installation. We recommend all Associations seek advice from a qualified consultant whenever they are considering having work performed on any building envelope components (roof, walls, windows, decks, exterior painting and caulking/sealant).

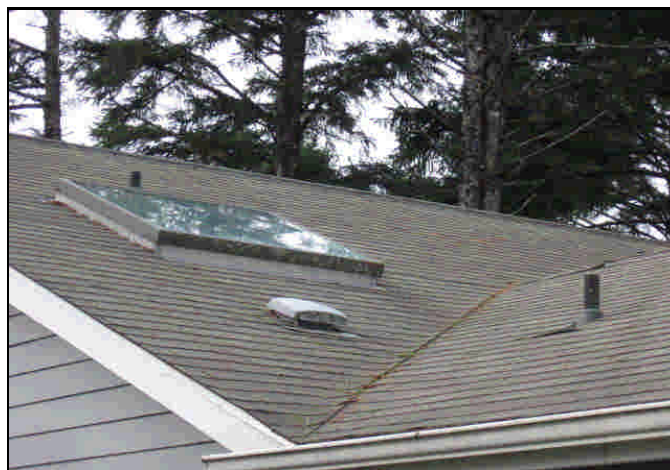
**Comp #:** 500 Bldg 96 E-H Roof - Replace

Evaluation: Roofing is three tab shingles; original, installed in 1996. No reported leaks, no missing shingles or obvious damage. Ventilation (the lack of which can greatly reduce useful life) was observed at the eave; ridge was difficult to observe due to height. Eave venting consisted of circular holes in blocking between rafters. Visible portions of roof flashing were observed at the rake, headwall, and sidewall conditions. Gutters blocked the view of eaves, so eave flashing was not confirmed.

This type of roofing typically has a 15 to 18 year service life assuming it was properly installed and is properly maintained. As routine maintenance, many manufacturers recommend inspections at least twice annually (once in the fall, before the rainy season, and again in the spring) and after large storm events. Promptly replace any damaged/missing sections or any other repair needed to ensure waterproof integrity of roof. Keep roof surface, gutters and downspouts clear and free of moss or debris. Moss growth can decrease the life of the roofing shingles and should be removed sooner than later. Liquid applied fungicide (moss killer) is recommended instead of power washing the living moss off the shingles. Moss roots grow into the shingles. Killing the moss in place, with a fungicide, allows the roots to gradually release from the shingles. After roots have died and released, then the moss can be removed (with broom or low pressure water) taking care to not damage the shingles. Do not use high-pressure water to remove moss as the high-pressure can loosen granular surface of shingles, erode the shingle surface, reducing the remaining useful life.

Plan for replacement at roughly the time frame indicated below. Costs below include replacing with a similar shingle to what is currently in place. We suggest that the best value (life cycle cost) might be to spend about \$2 - \$3/square foot more and install a 50-year shingle.

At time of re-roof we recommend that you hire a professional roof consultant such as Architect, Engineer, or building envelope consultant; to evaluate, design, specify, help bid the project, select best bidder, and observe construction to ensure proper installation. We recommend all Associations seek advice from a qualified consultant whenever they are considering having work performed on any building envelope components (roof, walls, windows, decks, exterior painting and caulking/sealant).

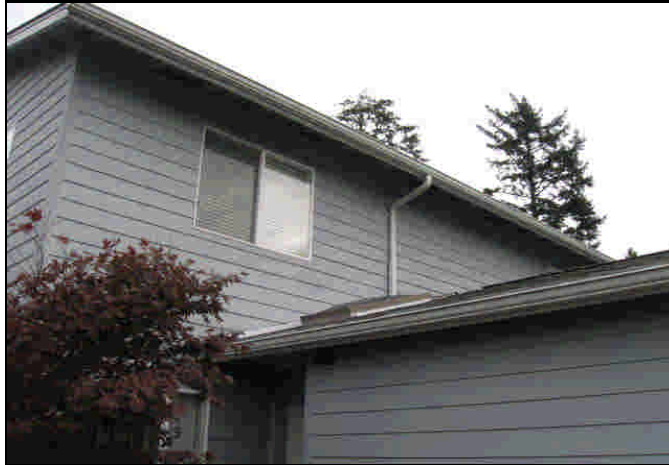
**Comp #:** 508 Bldg 66 Skylights - Replace

Evaluation: Up close observation of skylights was not possible due to limited access and location of skylights. In viewing from ground, stainless flashing was noted with rust on fasteners. Skylights are reportedly original plastic and near the end of their useful life.

Inspect skylights during roof inspection and repair as needed to maintain waterproof integrity. Typical quality skylight useful life is in the 30 year range.

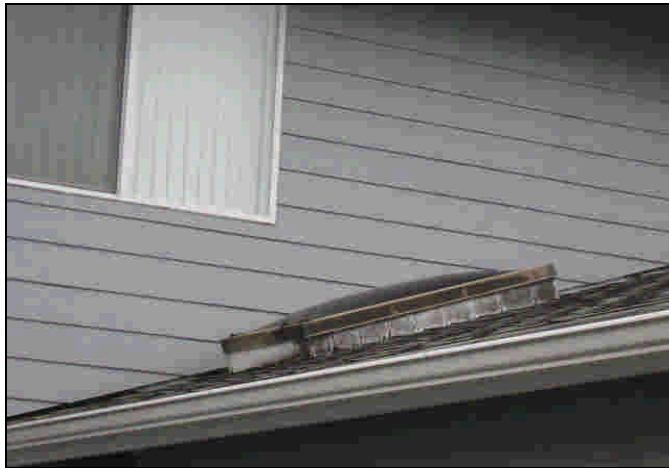
**Comp #:** 508 Bldg 76 Skylights - Replace

Evaluation: Up close observation of skylights was not possible due to limited access and location of skylights. In viewing from ground, stainless flashing was noted with rust on fasteners. Skylights are reportedly original plastic and near the end of their useful life.

Inspect skylights during roof inspection and repair as needed to maintain waterproof integrity. Typical quality skylight useful life is in the 30 year range.

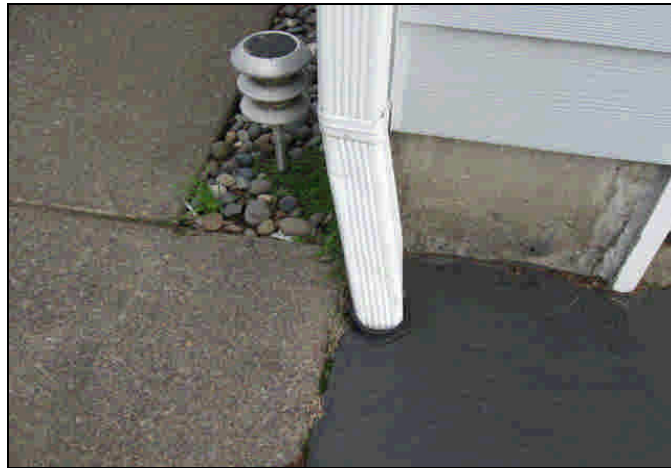
Evaluation: Generally the aluminum gutters and downspouts appeared in fair condition. Some local dents and dings were noted. Terminated into a drainage system - we assume adequate.

As routine maintenance, inspect regularly, keep gutters and downspouts free of debris. National Roofing Contractor Association (NRCA) roofing standard includes installing eave flashings at the gutters. We suggest to plan for total replacement of gutter and downspouts at roughly the time frame below, best timed with roofing.

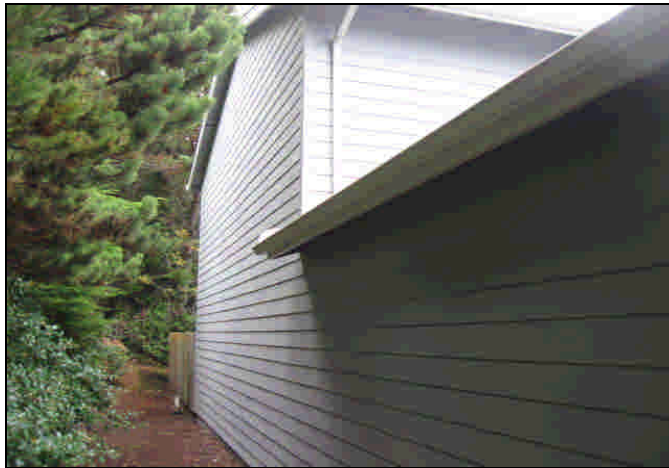
Evaluation: Generally the aluminum gutters and downspouts appeared in fair condition. Some local dents and dings were noted. Terminated into a drainage system - we assume adequate.

As routine maintenance, inspect regularly, keep gutters and downspouts free of debris. National Roofing Contractor Association (NRCA) roofing standard includes installing eave flashings at the gutters. We suggest to plan for total replacement of gutter and downspouts at roughly the time frame below, best timed with roofing.

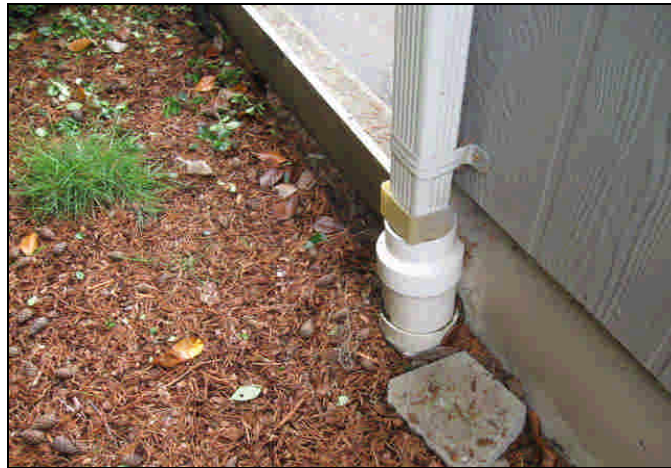
Evaluation: Generally the aluminum gutters and downspouts appeared in fair to good condition. Terminated into a drainage system - we assume adequate.

As routine maintenance, inspect regularly, keep gutters and downspouts free of debris. National Roofing Contractor Association (NRCA) roofing standard includes installing eave flashings at the gutters. We suggest to plan for total replacement of gutter and downspouts at roughly the time frame below, best timed with roofing.
