Client: 22568A North Shore Terrace

Comp #: 510 Bldg 86 Gutters/Dwnspts - Replace

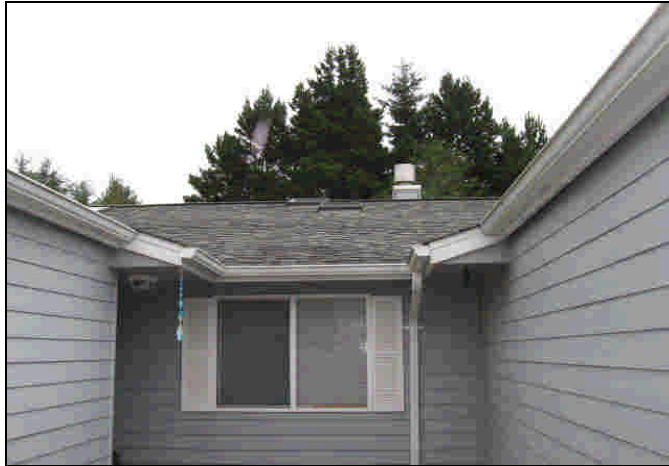
Evaluation: Generally the aluminum gutters and downspouts appeared in fair condition. Terminated into a drainage system - we assume adequate.

As routine maintenance, inspect regularly, keep gutters and downspouts free of debris. National Roofing Contractor Association (NRCA) roofing standard includes installing eave flashings at the gutters. We suggest to plan for total replacement of gutter and downspouts at roughly the time frame below, best timed with roofing.

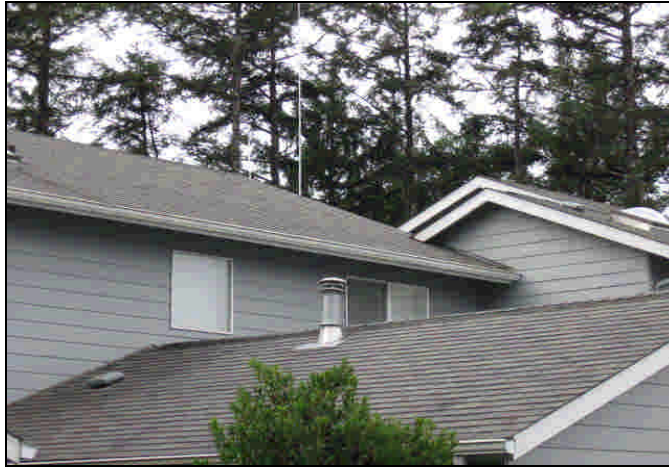
Comp #: 510 Bldg 96 A-D Gutters/Dwnspts - Rplc

Evaluation: Generally the aluminum gutters and downspouts appeared in fair to good condition. Terminated into a drainage system - we assume adequate.

As routine maintenance, inspect regularly, keep gutters and downspouts free of debris. National Roofing Contractor Association (NRCA) roofing standard includes installing eave flashings at the gutters. We suggest to plan for total replacement of gutter and downspouts at roughly the time frame below, best timed with roofing.

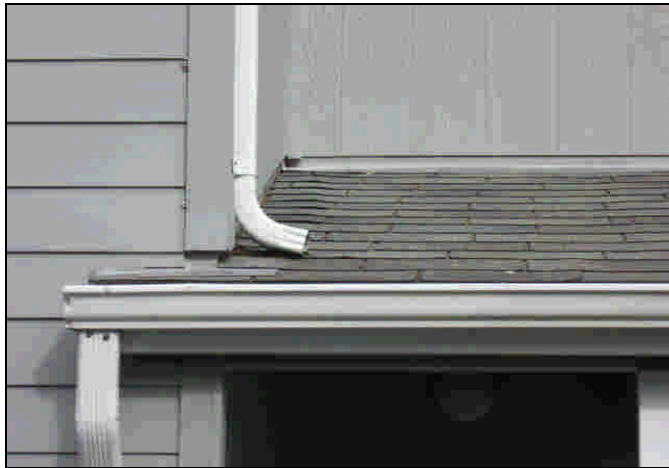
Comp #: 510 Bldg 96 E-H Gutters/Dwnspts - Rplc

Evaluation: Generally the aluminum gutters and downspouts appeared in fair to good condition. Terminated into a drainage system - we assume adequate.

As routine maintenance, inspect regularly, keep gutters and downspouts free of debris. National Roofing Contractor Association (NRCA) roofing standard includes installing eave flashings at the gutters. We suggest to plan for total replacement of gutter and downspouts at roughly the time frame below, best timed with roofing.

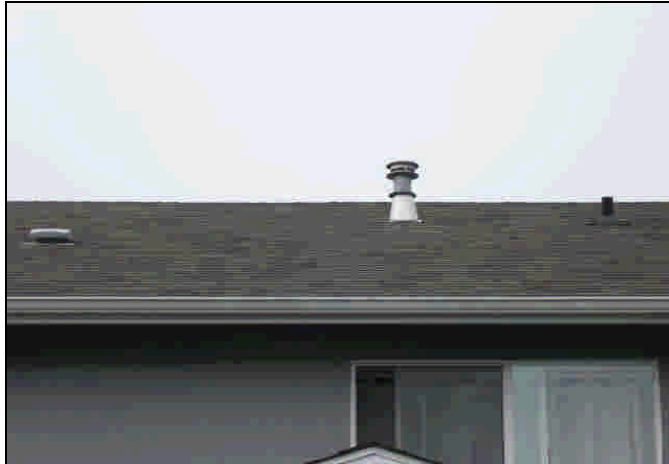
Comp #: 515 Bldg 85 Vent Hoods - Replace

Evaluation: Observation from ground level - no damage or unusual wear noted.

As routine maintenance, inspect and clean during roof maintenance, ensure proper attachment and seal. Repair locally as needed. This project should be less than the reserve funding threshold (<\$2,000) - best to treat as general operating / maintenance expense, not as cyclical reserve component.

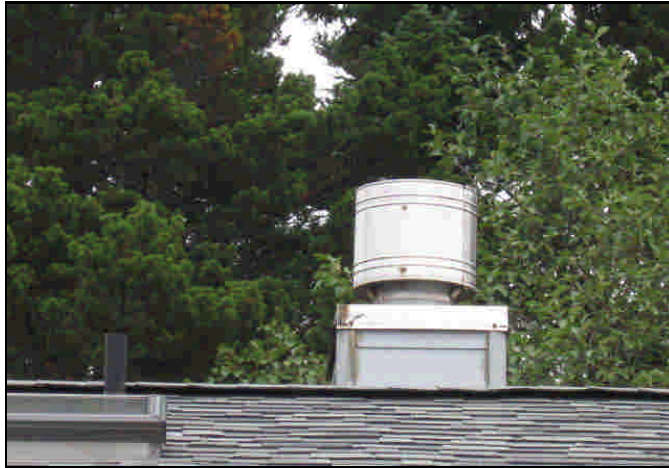
Evaluation: Did not observe close up. In viewing from ground level, appears to be stainless steel cap and flashing. Assumed to have been installed around time of siding replacement in 2001.

As routine maintenance, inspect and clean during roof maintenance. Ensure proper attachment and seal; repair locally as needed. Assuming proactive maintenance, plan for total replacement at roughly the time frame indicated below. Review condition of chimney caps and flue caps with consultant while evaluating the roofing project.

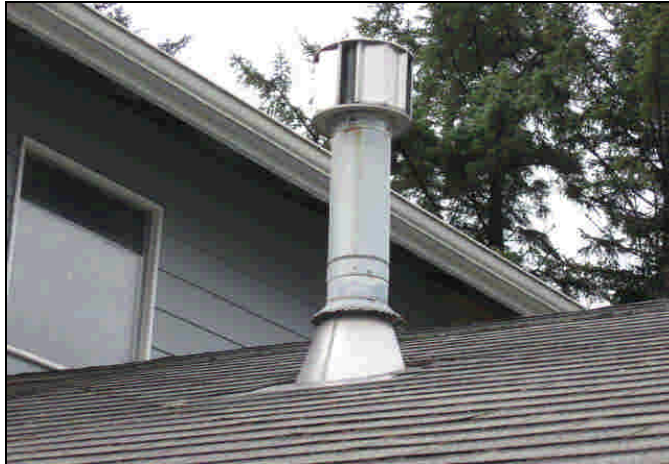
Comp #: 515 Bldg 96 A-D Vent Hoods - Replace

Evaluation: Observation from ground level - no damage or unusual wear noted.

As routine maintenance, inspect and clean during roof maintenance, ensure proper attachment and seal. Repair locally as needed. This project should be less than the reserve funding threshold (<\$2,000) - best to treat as general operating / maintenance expense, not as cyclical reserve component.

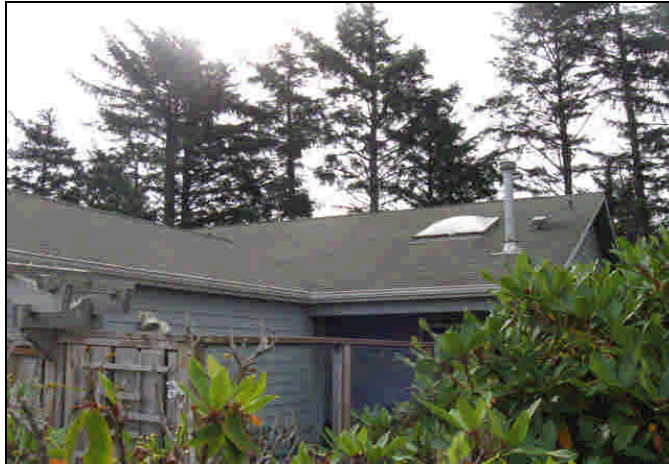
Comp #: 515 Bldg 96 E-H Vent Hoods - Replace

Evaluation: Observation from ground level - no damage or unusual wear noted.

As routine maintenance, inspect and clean during roof maintenance, ensure proper attachment and seal. Repair locally as needed. This project should be less than the reserve funding threshold (<\$2,000) - best to treat as general operating / maintenance expense, not as cyclical reserve component.

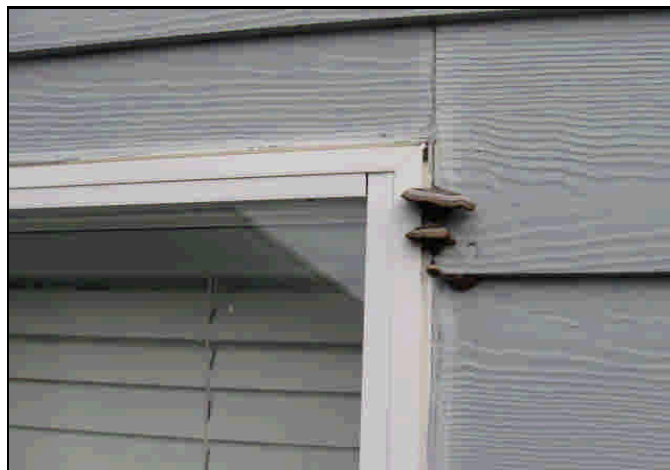
Evaluation: Horizontal fiber-cement siding. The paint appeared to be in fair condition. No extensive peeling or blistering observed, but generally faded. The sealants (caulking) show voids and need to be redone soon. When the buildings were re-sided, head flashings were not installed at the windows and the frames are caulked to the siding at the head. This can result in any water that makes its way beneath the siding to become trapped and lead to damage. Fungal growth was noted at the window frame between 66 A & B (see photo). This should be investigated soon - the association should consider remedial measures to correct, or at minimum ensure properly designed sealant joints with top quality material be installed until the windows are replaced and the openings are properly waterproofed.

As routine maintenance, inspect regularly (including sealants) repair locally and touch-up paint as needed. Typical Northwest paint cycles vary greatly depending upon many factors including; type of material painted, surface preparations, quality of primer/paint/stain, application methods, weather conditions during application, moisture beneath paint, and exposure to weather conditions.

Proper sealant/caulking is critical to keeping water out of the walls, and preventing water damage. Two common types of sealants/caulking are urethane and silicone. If properly installed, urethane has a life of approximately 6-9 years and silicone's life can be 16-20 years. Incorrect installations of sealant are common, and can greatly decrease its useful life. Inspect sealant, more frequently as it ages, to determine if it is failing. Typical sealant problems include failure of sealant to adhere to adjacent materials and tearing/splitting of the sealant itself. As sealants age and are exposure to ultra-violet sunlight, they will dry out, harden, and lose their elastic ability. Remove and replace sealant as signs of failure begin to appear. Proper cleaning, prep work, and proper installation are critical for a long lasting sealant/caulking. Do not install sealant in locations that would block water drainage from behind the siding. Repair areas as needed prior to painting/caulking.

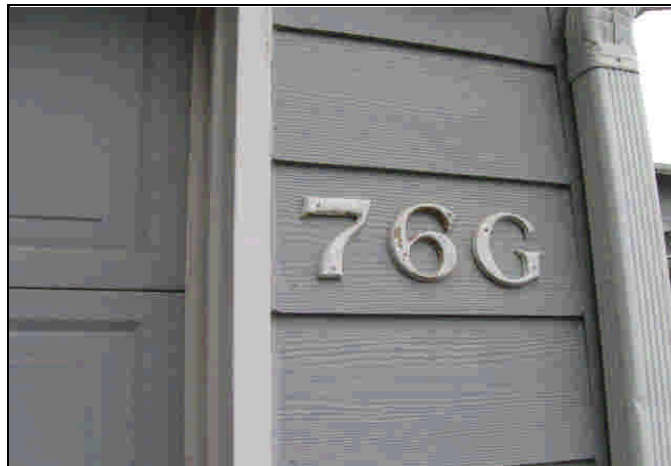
Evaluation: Horizontal fiber-cement siding. The paint appeared to be in fair condition. No extensive peeling or blistering observed, but generally faded. The sealants (caulking) show voids and need to be redone soon. When the buildings were re-sided, head flashings were not installed at the windows and the frames are caulked to the siding at the head. This can result in any water that makes its way beneath the siding to become trapped and lead to damage. Condominium reported that they last painted in 2001.

As routine maintenance, inspect regularly (including sealants) repair locally and touch-up paint as needed. Typical Northwest paint cycles vary greatly depending upon many factors including; type of material painted, surface preparations, quality of primer/paint/stain, application methods, weather conditions during application, moisture beneath paint, and exposure to weather conditions.

Proper sealant/caulking is critical to keeping water out of the walls, and preventing water damage. Two common types of sealants/caulking are urethane and silicone. If properly installed, urethane has a life of approximately 6-9 years and silicone's life can be 16-20 years. Incorrect installations of sealant are common, and can greatly decrease its useful life. Inspect sealant, more frequently as it ages, to determine if it is failing. Typical sealant problems include failure of sealant to adhere to adjacent materials and tearing/splitting of the sealant itself. As sealants age and are exposure to ultra-violet sunlight, they will dry out, harden, and lose their elastic ability. Remove and replace sealant as signs of failure begin to appear. Proper cleaning, prep work, and proper installation are critical for a long lasting sealant/caulking. Do not install sealant in locations that would block water drainage from behind the siding. Repair areas as needed prior to painting/caulking.

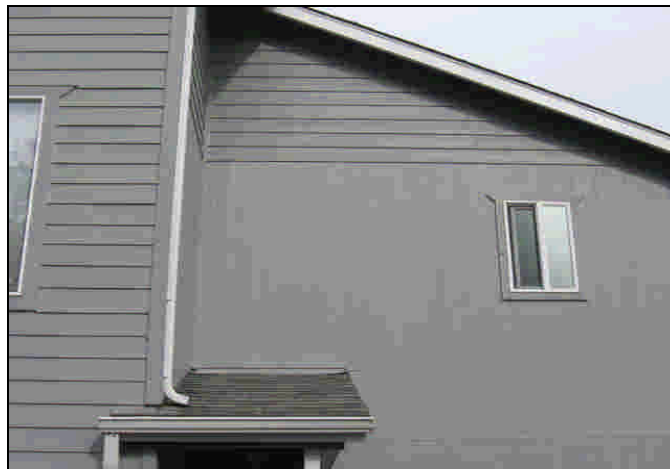
Evaluation: Horizontal fiber-cement siding. The south elevation siding was reportedly replaced and subsequently painted in 2008 / 2009. The paint appeared to be in fair condition with general fading and wear, but no peeling or blistering observed.

The south side may just need to be touched up at the next scheduled paint job.

As routine maintenance, inspect regularly (including sealants) repair locally and touch-up paint as needed. Typical Northwest paint cycles vary greatly depending upon many factors including; type of material painted, surface preparations, quality of primer/paint/stain, application methods, weather conditions during application, moisture beneath paint, and exposure to weather conditions.

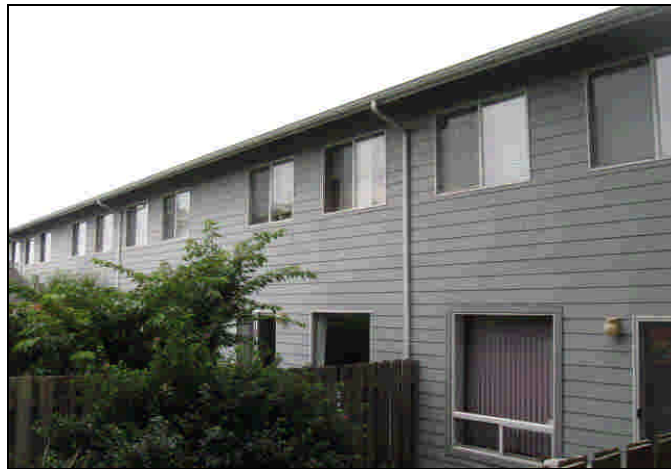
Evaluation: Horizontal fiber-cement siding, replaced in phases (S & W in 2001, N & E in 2010). Because of this phased siding approach on different elevations, we have scheduled building 86 herein as two separate projects, with the N & E elevations due again in 2020. The paint appeared to be in good condition.

As routine maintenance, inspect regularly (including sealants) repair locally and touch-up paint as needed. Typical Northwest paint cycles vary greatly depending upon many factors including; type of material painted, surface preparations, quality of primer/paint/stain, application methods, weather conditions during application, moisture beneath paint, and exposure to weather conditions.

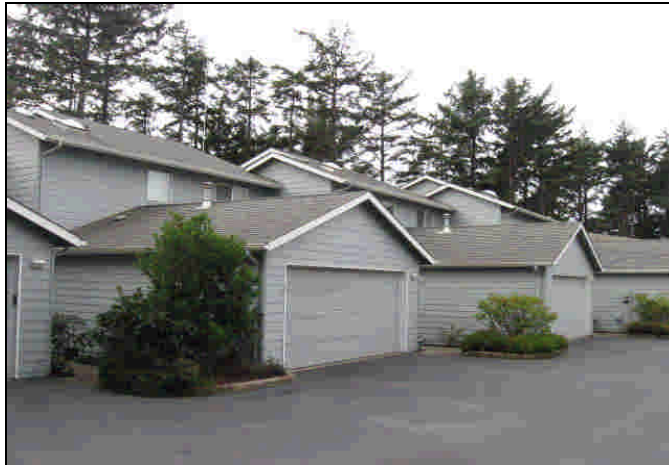
Evaluation: Horizontal fiber-cement siding, replaced in phases (S & W in 2001, N & E in 2010). Because of this phased siding approach on different elevations, we have scheduled building 86 herein as two separate projects, with the S & W elevations due in 2014. The paint appeared to be in fair condition with general fading and wear, but no peeling or blistering observed.

As routine maintenance, inspect regularly (including sealants) repair locally and touch-up paint as needed. Typical Northwest paint cycles vary greatly depending upon many factors including; type of material painted, surface preparations, quality of primer/paint/stain, application methods, weather conditions during application, moisture beneath paint, and exposure to weather conditions.

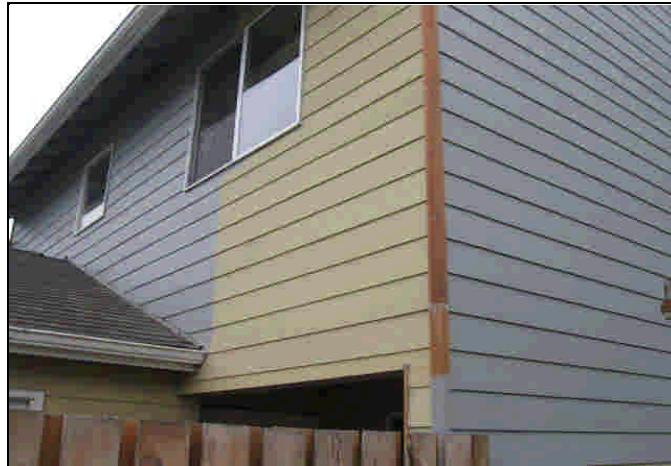
Evaluation: Siding has been replaced in a phased manner over time from 2003 to 2011; painting occurred at the end of each siding project.

We recommend a cyclical project for the whole building in future years - scheduled below to occur next in 2017. Evaluate and adjust remaining useful life as it approaches zero years.

As routine maintenance, inspect regularly (including sealants) repair locally and touch-up paint as needed. Typical Northwest paint cycles vary greatly depending upon many factors including; type of material painted, surface preparations, quality of primer/paint/stain, application methods, weather conditions during application, moisture beneath paint, and exposure to weather conditions.

Inspect sealant, more frequently as it ages, to determine if it is failing. Typical sealant problems include failure of sealant to adhere to adjacent materials and tearing/splitting of the sealant itself. As sealants age and are exposure to ultra-violet sunlight, they will dry out, harden, and lose their elastic ability. Remove and replace sealant as signs of failure begin to appear. Proper cleaning, prep work, and proper installation are critical for a long lasting sealant/caulking. Do not install sealant in locations that would block water drainage from behind the siding. Repair areas as needed prior to painting/caulking.

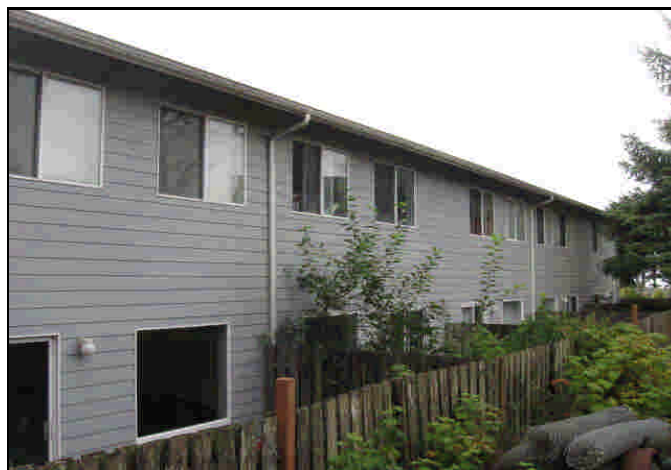
Comp #: 535 Bldg. 66 Windows,Sliders - Replace

Evaluation: Windows were vinyl frames with horizontal sliders, and fixed operation. Head flashing was not observed - should be added when replacement occurs. Be careful to properly sequence the flashing with the WRB below siding and do not caulk the new flashing to the siding. Current jambs and sills had sealant joint between window frame and cladding that is failing. Weep holes, at exterior lower corners, were observed to be clear, in the few windows sampled for our report. Some condensation was observed between window panes, which is typically indicative of failed glazing seals.

Inspect regularly, including sealant, and repair as needed using operating / maintenance funds. Keep weep holes free and clear to allow proper drainage of water that gets into window frame.

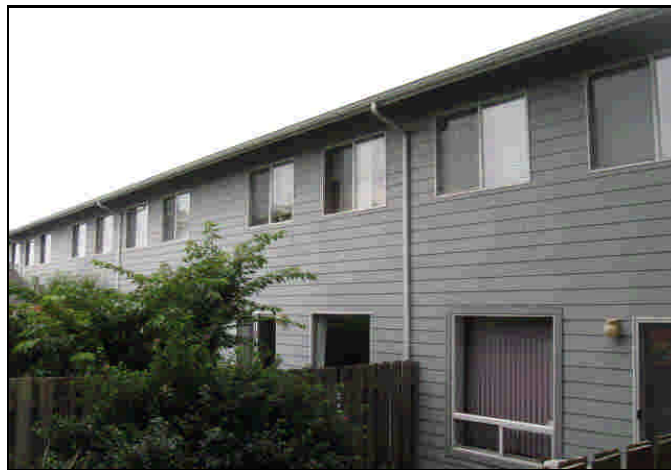
Comp #: 535 Bldg. 76 Windows,Sliders - Replace

Evaluation: Windows were vinyl frames with horizontal sliders, and fixed operation. Head flashing was not observed - should be added when replacement occurs. Be careful to properly sequence the flashing with the WRB below siding and do not caulk the new flashing to the siding. Current jambs and sills had sealant joint between window frame and cladding that is failing. Weep holes, at exterior lower corners, were observed to be clear, in the few windows sampled for our report. Some condensation was observed between window panes, which is typically indicative of failed glazing seals.

Inspect regularly, including sealant, and repair as needed using operating / maintenance funds. Keep weep holes free and clear to allow proper drainage of water that gets into window frame.

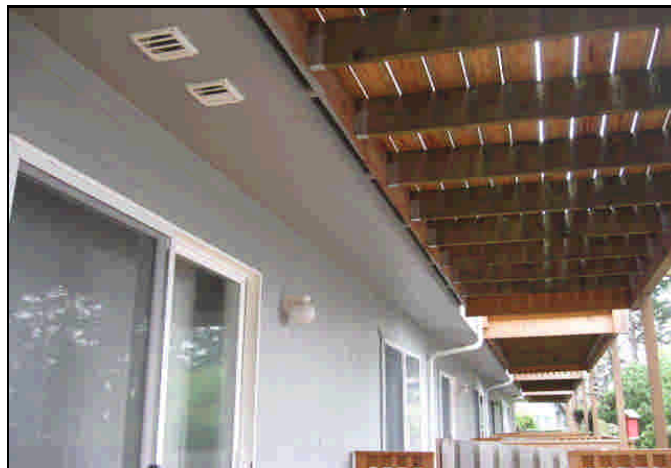
Comp #: 535 Bldg. 85 Windows,Sliders - Replace

Evaluation: Windows were vinyl frames with horizontal sliders, and fixed operation. Head flashing was not observed - should be added when replacement occurs. Be careful to properly sequence the flashing with the WRB below siding and do not caulk the new flashing to the siding. Current jambs and sills had sealant joint between window frame and cladding that is failing. Weep holes, at exterior lower corners, were observed to be clear, in the few windows sampled for our report. Some condensation was observed between window panes, which is typically indicative of failed glazing seals.

Inspect regularly, including sealant, and repair as needed using operating / maintenance funds. Keep weep holes free and clear to allow proper drainage of water that gets into window frame.

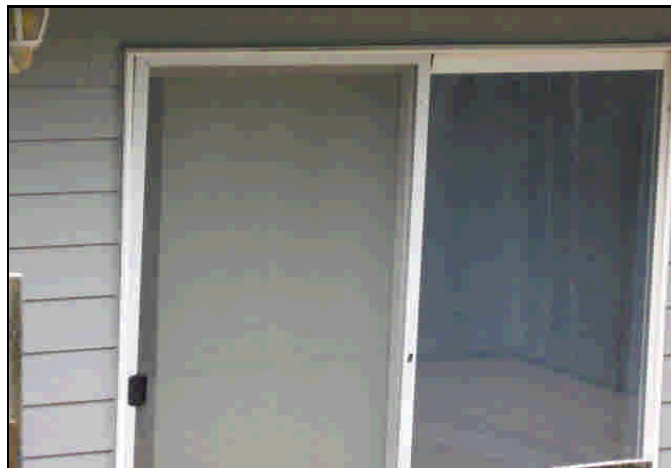
Comp #: 535 Bldg. 86 Windows,Sliders - Replace

Evaluation: Windows were vinyl frames with horizontal sliders, and fixed operation. Head flashing was not observed - should be added when replacement occurs. Be careful to properly sequence the flashing with the WRB below siding and do not caulk the new flashing to the siding. Current jambs and sills had sealant joint between window frame and cladding that is failing. Weep holes, at exterior lower corners, were observed to be clear, in the few windows sampled for our report. Some condensation was observed between window panes, which is typically indicative of failed glazing seals.

Inspect regularly, including sealant, and repair as needed using operating / maintenance funds. Keep weep holes free and clear to allow proper drainage of water that gets into window frame.

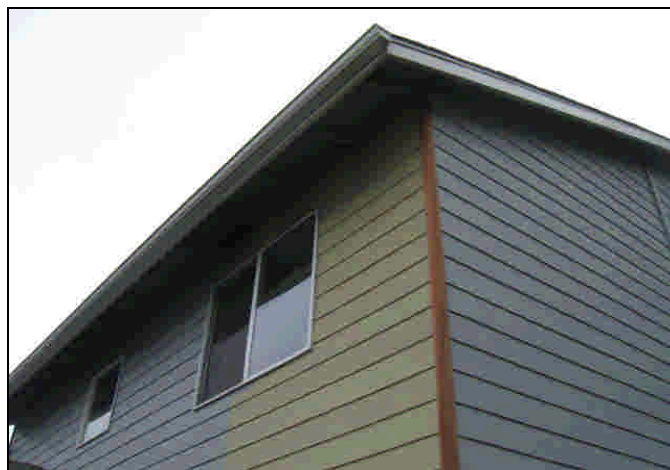
Comp #: 535 Bldg. 96 A-D Wndws,Sldrs - Replace

Evaluation: Windows were vinyl frames with horizontal sliders, and fixed operation. Head flashing was not observed - should be added when replacement occurs. Be careful to properly sequence the flashing with the WRB below siding and do not caulk the new flashing to the siding. Current jambs and sills had sealant joint between window frame and cladding that is failing. Weep holes, at exterior lower corners, were observed to be clear, in the few windows sampled for our report.

Inspect regularly, including sealant, and repair as needed using operating / maintenance funds. Keep weep holes free and clear to allow proper drainage of water that gets into window frame.

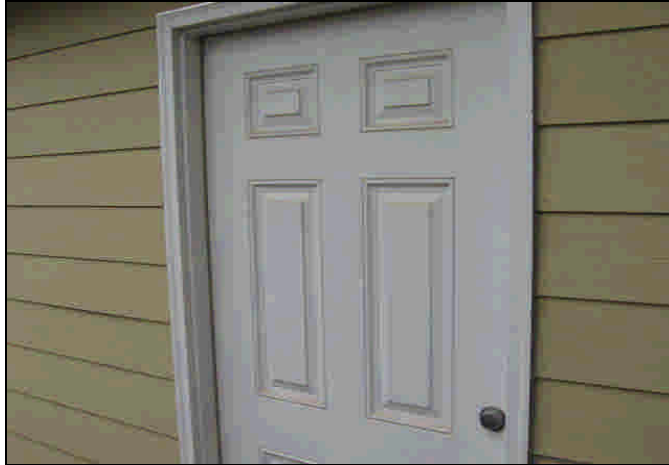
Evaluation: Exterior doors were mostly metal. Some local replacement due to rust and wear. New man door at 96 bldg. Noted to be fiberglass. Expect similar replacement needs over time, but not on schedule as predictable reserve project. We suggest inspecting each year and allocating any replacement funding needs within the operating / maintenance budget.

Door painting is included as part of exterior painting. Touch up paint as needed between painting cycles. Inspect periodically and repair as needed to maintain appearance, security and operation with maintenance funds. No predictable large scale repair or replacement of doors. No reserve funding suggested.

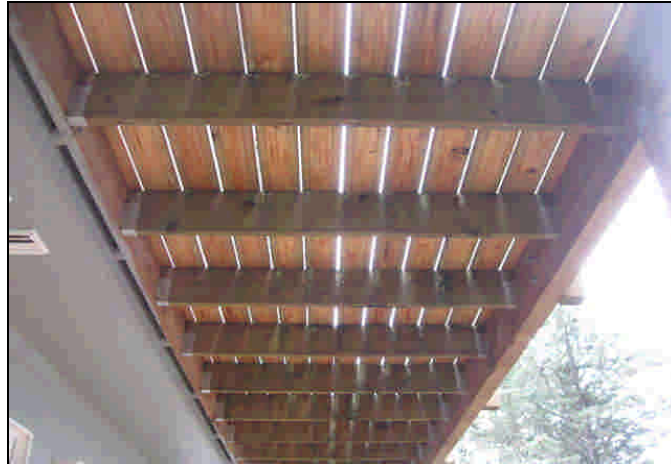
Evaluation: Deck surface is open boards that allows water to drain off between wood boards. Rebuilt in 2009; contractor indicated deck boards and rail assembly replaced, not structural beams / joists.

We have factored 20 year replacement cycles below - RUL is increased by one year from chronological age to allow for cyclical staining of all decks. Allowance a little higher than 66 / 76 due to access restrictions and height.

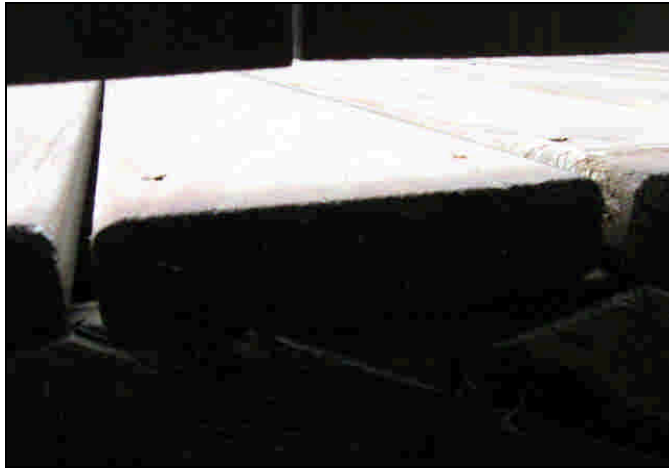
Condominium reported these were replaced in 2010 at association expense.

Inspect deck, stairs, and railings annually and repair as needed. As part of maintenance, apply water repellent stain/preservative periodically - see component #540. Almost all exterior wood in the Northwest will decay over time and require replacement. Options for a longer lasting deck include such things as using a thick wood boards (treated, cedar, etc...) or a composite product. Composite materials are available that require less maintenance. Funding for replacing existing wood boards with in-kind material is factored below. Costs can increase greatly, if decay of the structural framing is found.

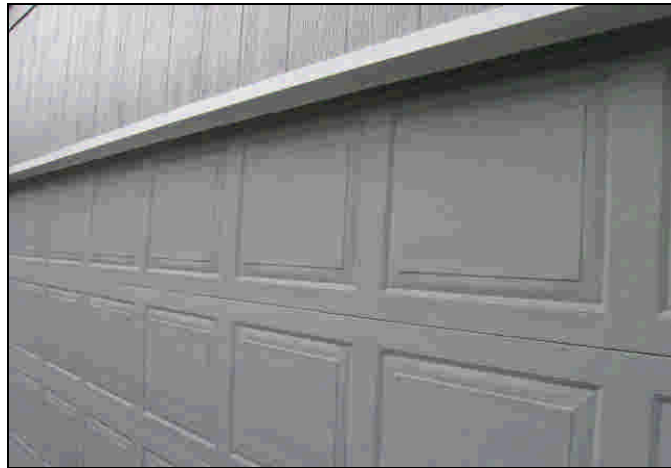
Location: Garage entry

Evaluation: Varying appearance - some history of door replacement. All appeared to be generally in functional condition during our site visit. These door types can last for many years if properly maintained and not damaged or abused. Without a basis for cyclical replacement funding, it is more appropriate to factor any periodic replacement needs within the annual operating budget - or - if future conditions indicate a larger project is needed, funding can be incorporated within a future reserve study update. No reserve funding suggested at this time.
