Update "With-Site-Visit" Reserve Study

North Shore Terrace Newport, OR

Report #: 22568-1
For Period Beginning: January 1, 2019
Expires: December 31, 2019

Date Prepared: July 11, 2018

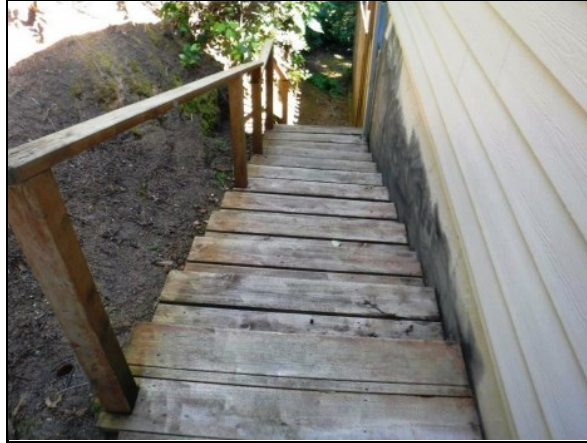
Useful Life:
25 years

Remaining Life:
5 years

Best Case: \$ 2,500

Worst Case: \$ 4,500

# Component	Quantity	Useful Life	Rem. Useful Life	Current Cost Estimate		
				Best Case	Worst Case	
Site / Grounds						
110	Site Stairs - Repair/Replace	(1) wood stair set	25	5	\$2,500	\$4,500
120	Asphalt - Resurface	~ 30,100 SF	35	11	\$75,300	\$90,300
121	Asphalt - Seal/Repair/Stripe	~ 30,100 SF	6	0	\$7,500	\$9,000
160	Pole Lights - Replace	(9) fixtures	25	0	\$4,400	\$6,600
205	Mailboxes/Shelter - Replace	(7) stands	20	0	\$9,500	\$12,100
Building Exterior						
140	Bldg 66 Wood Fence - Replace	~ (330) LF	20	13	\$8,300	\$11,600
140	Bldg 76 Wood Fence - Replace	~ (220) LF	20	13	\$5,500	\$7,700
140	Bldg 85 Wood Fence - Replace	~ (165) LF	20	17	\$4,100	\$5,800
140	Bldg 86 Wood Fence - Replace	~ (340) LF	20	4	\$8,500	\$11,900
140	Bldg 96 A-D Wood Fence - Replace	~ (160) LF	20	13	\$4,000	\$5,600
140	Bldg 96 E-H Wood Fence - Replace	~ (140) LF	20	18	\$3,500	\$4,900
500	Bldg 66 Roof - Replace	~ 7,500 SF	30	18	\$30,000	\$38,000

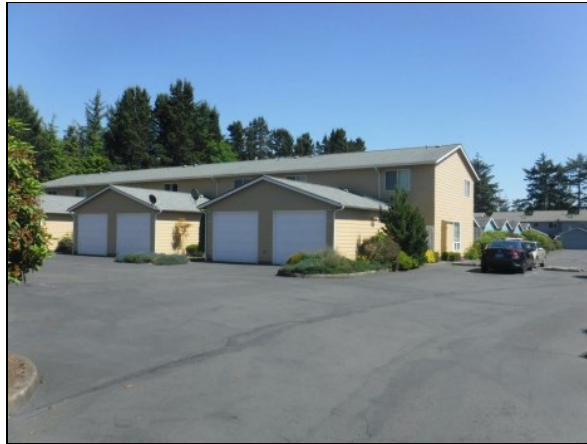
Useful Life:
35 years

Remaining Life:
11 years

Best Case: \$ 75,300

Worst Case: \$ 90,300

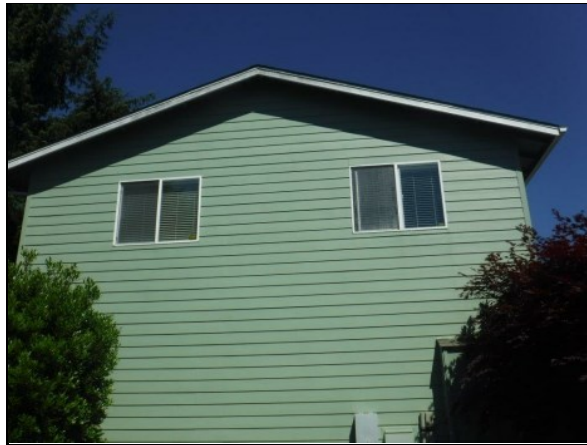
Useful Life:
50 years

Remaining Life:
24 years

Best Case: \$ 89,000

Worst Case: \$ 134,000

Replacement may ultimately be needed due to the failure of the underlying waterproofing degrading over the decades, and/or the end of the useful life of the siding materials from general aging. Many factors influence the useful life, including exposure to (or protection from) wind driven rain, and the quality of the waterproofing and flashing beneath the siding. Evaluate the siding and the critical underlying waterproofing (typically building paper or house-wrap) more frequently as the remaining useful life approaches zero years. Adjust remaining useful life as dictated by the evaluation. Align with window replacement for cost efficiencies and building envelope integrity when practical. Inspect annually and repair locally as needed using general maintenance funds.

Project costs can vary depending upon materials chosen and the condition of the underlying structural framing when exposed. We recommend the Board conduct research well in advance in order to define scope, timing and costs, including plan for some margin of contingency.

Note: At replacement we highly recommend including building enclosure design documents with waterproofing details by an architect or engineer, and independent oversight during construction to verify compliance with those details.

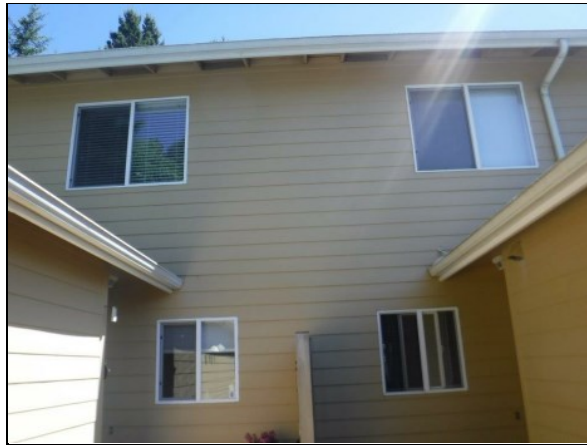
Useful Life:
50 years

Remaining Life:
24 years

Best Case: \$ 89,000

Worst Case: \$ 134,000

Replacement may ultimately be needed due to the failure of the underlying waterproofing degrading over the decades, and/or the end of the useful life of the siding materials from general aging. Many factors influence the useful life, including exposure to (or protection from) wind driven rain, and the quality of the waterproofing and flashing beneath the siding. Evaluate the siding and the critical underlying waterproofing (typically building paper or house-wrap) more frequently as the remaining useful life approaches zero years. Adjust remaining useful life as dictated by the evaluation. Align with window replacement for cost efficiencies and building envelope integrity when practical. Inspect annually and repair locally as needed using general maintenance funds.

Project costs can vary depending upon materials chosen and the condition of the underlying structural framing when exposed. We recommend the Board conduct research well in advance in order to define scope, timing and costs, including plan for some margin of contingency.

Note: At replacement we highly recommend including building enclosure design documents with waterproofing details by an architect or engineer, and independent oversight during construction to verify compliance with those details.

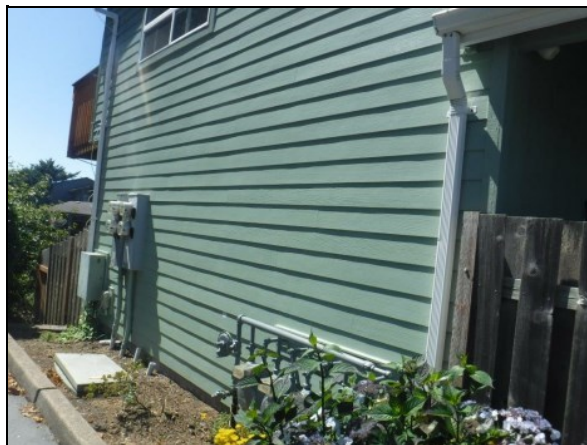
Useful Life:
50 years

Remaining Life:
28 years

Best Case: \$ 66,000

Worst Case: \$ 99,000

Replacement may ultimately be needed due to the failure of the underlying waterproofing degrading over the decades, and/or the end of the useful life of the siding materials from general aging. Many factors influence the useful life, including exposure to (or protection from) wind driven rain, and the quality of the waterproofing and flashing beneath the siding. Evaluate the siding and the critical underlying waterproofing (typically building paper or house-wrap) more frequently as the remaining useful life approaches zero years. Adjust remaining useful life as dictated by the evaluation. Align with window replacement for cost efficiencies and building envelope integrity when practical. Inspect annually and repair locally as needed using general maintenance funds.

Project costs can vary depending upon materials chosen and the condition of the underlying structural framing when exposed. We recommend the Board conduct research well in advance in order to define scope, timing and costs, including plan for some margin of contingency.

Note: At replacement we highly recommend including building enclosure design documents with waterproofing details by an architect or engineer, and independent oversight during construction to verify compliance with those details.

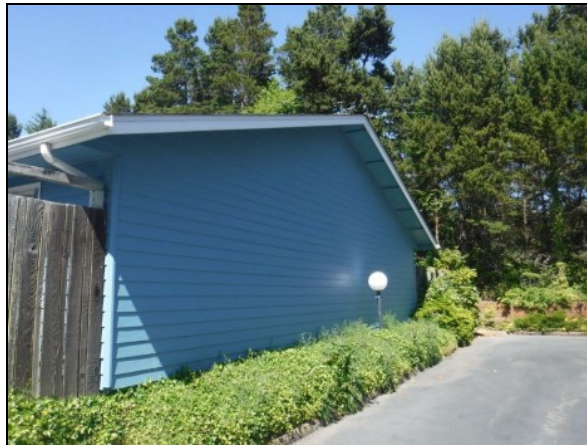
Useful Life:
50 years

Remaining Life:
28 years

Best Case: \$ 66,000

Worst Case: \$ 98,000

Replacement may ultimately be needed due to the failure of the underlying waterproofing degrading over the decades, and/or the end of the useful life of the siding materials from general aging. Many factors influence the useful life, including exposure to (or protection from) wind driven rain, and the quality of the waterproofing and flashing beneath the siding. Evaluate the siding and the critical underlying waterproofing (typically building paper or house-wrap) more frequently as the remaining useful life approaches zero years. Adjust remaining useful life as dictated by the evaluation. Align with window replacement for cost efficiencies and building envelope integrity when practical. Inspect annually and repair locally as needed using general maintenance funds.

Project costs can vary depending upon materials chosen and the condition of the underlying structural framing when exposed. We recommend the Board conduct research well in advance in order to define scope, timing and costs, including plan for some margin of contingency.

Note: At replacement we highly recommend including building enclosure design documents with waterproofing details by an architect or engineer, and independent oversight during construction to verify compliance with those details.

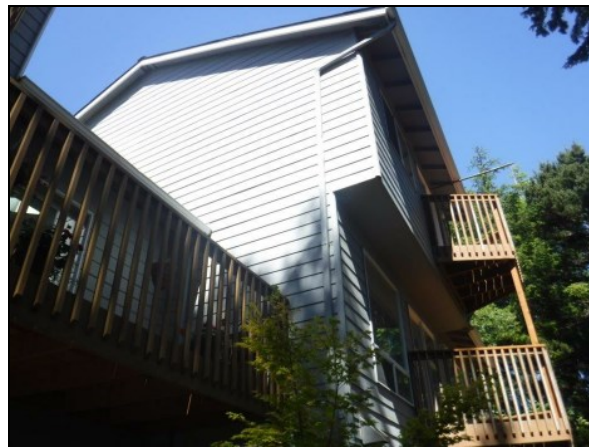
Useful Life:
50 years

Remaining Life:
27 years

Best Case: \$ 104,000

Worst Case: \$ 157,000

Replacement may ultimately be needed due to the failure of the underlying waterproofing degrading over the decades, and/or the end of the useful life of the siding materials from general aging. Many factors influence the useful life, including exposure to (or protection from) wind driven rain, and the quality of the waterproofing and flashing beneath the siding. Evaluate the siding and the critical underlying waterproofing (typically building paper or house-wrap) more frequently as the remaining useful life approaches zero years. Adjust remaining useful life as dictated by the evaluation. Align with window replacement for cost efficiencies and building envelope integrity when practical. Inspect annually and repair locally as needed using general maintenance funds.

Project costs can vary depending upon materials chosen and the condition of the underlying structural framing when exposed. We recommend the Board conduct research well in advance in order to define scope, timing and costs, including plan for some margin of contingency.

Note: At replacement we highly recommend including building enclosure design documents with waterproofing details by an architect or engineer, and independent oversight during construction to verify compliance with those details.

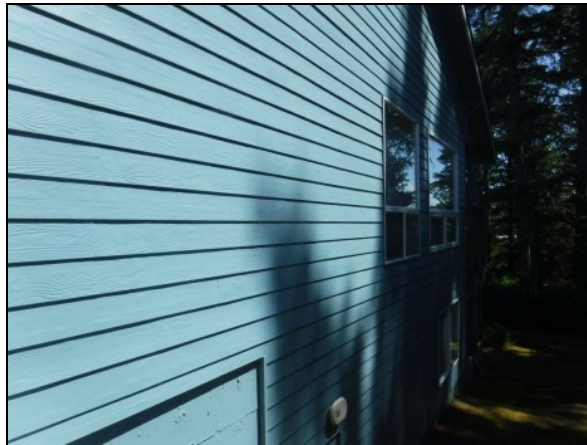
Useful Life:
50 years

Remaining Life:
25 years

Best Case: \$ 78,000

Worst Case: \$ 117,000

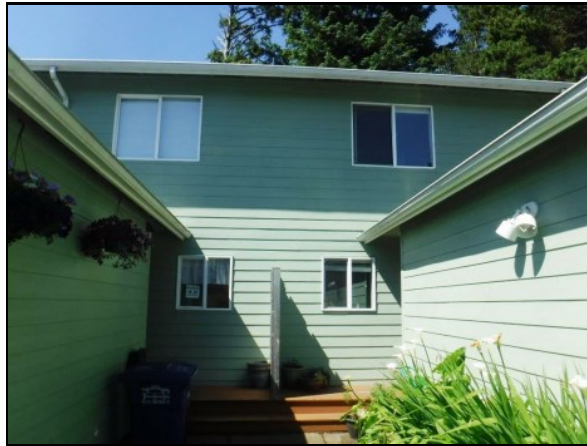
Useful Life:
10 years

Remaining Life:
4 years

Best Case: \$ 15,400

Worst Case: \$ 17,800

Evaluation: The painted surface of the siding and trim appeared in fair condition with no peeling or blistering observed.

Typical Northwest paint cycles vary greatly depending upon many factors including type of material painted, surface preparation, quality of primer/paint/stain, application methods, weather conditions during application, moisture beneath surface, and exposure to weather conditions. Repair areas as needed prior to painting/caulking. As routine maintenance, inspect regularly (including sealants) repair locally, and touch-up paint as needed using operating funds.

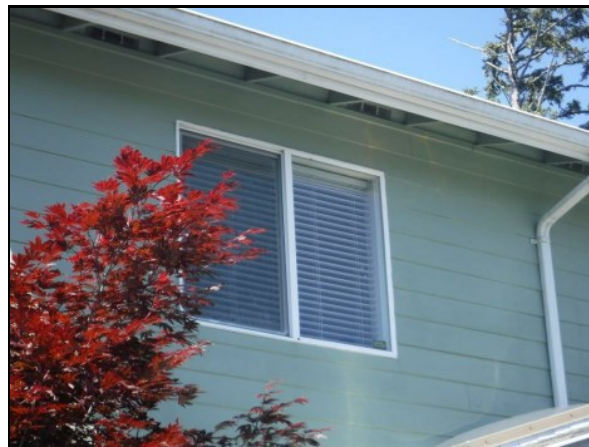
Useful Life:
30 years

Remaining Life:
3 years

Best Case: \$ 34,500

Worst Case: \$ 51,700

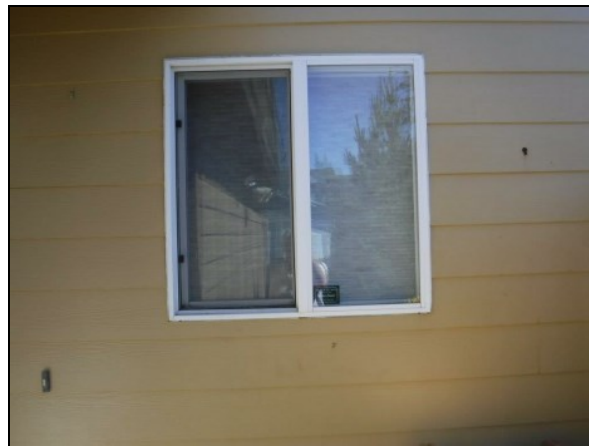
Useful Life:
30 years

Remaining Life:
3 years

Best Case: \$ 34,500

Worst Case: \$ 51,700
